## CASE STUDY

# Reducing Patient Risk in the ER Waiting Room at Meadville Medical Center

Implementing Visium Far-UVC fixtures reduces microbial load on high-touch surfaces.

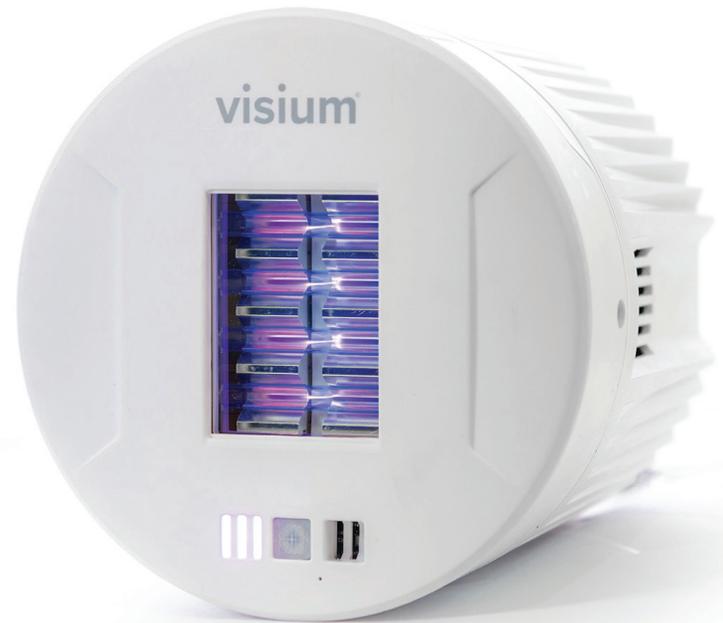
Eleven Visium devices were installed across the Emergency Room waiting area, focusing on intake areas and where patients are seated. Far-UVC continuously inactivates bioaerosols and surface bioburden, covering 525 sqft of active space. Devices were recessed into the ceiling for seamless integration within the space.

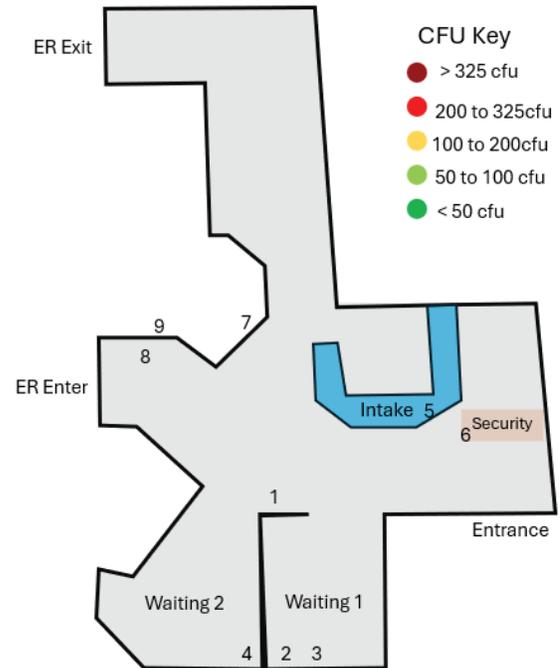
## Meadville ER Waiting Room

- 1 Charging Station
- 2 Table 1
- 3 Chair
- 4 Table 2
- 5 Reception
- 6 Security Table
- 7 Door Handle
- 8 Floor
- 9 Wall

- High → Medium
- Medium → Medium
- High → Medium
- Medium → Low
- Medium → Low
- High → Medium
- Medium → Low
- Low → Low
- High → Low

Change in Surface Bacteria Counts with Visium Use

Results showed that Visium reduced bacterial abundance on high-touch surfaces by up to 99% compared to conditions without Far-UVC. On average, the waiting room experienced a 63% reduction in overall bioburden. Location-specific changes in colony-forming units (CFUs) are illustrated in the room diagram. The largest individual reductions were observed on a door handle and a chair in the waiting room. While some locations, such as the Security Reception area, showed higher CFUs after sampling, pathogen risk was lower, underscoring that CFU counts alone do not fully reflect surface safety. Reductions in high-risk pathogens indicate surfaces were safer for contact with Visium use.

In addition to lowering total bioburden, Visium inactivated several high-risk pathogens on sampled surfaces. Risk profiles for each sampling location, based on identified organisms, are shown in the room diagram and demonstrate a room-wide reduction in potentially harmful pathogens.
